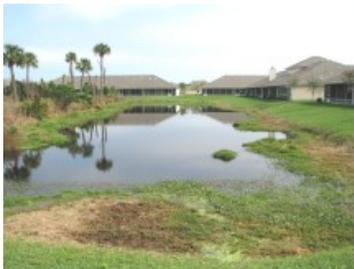
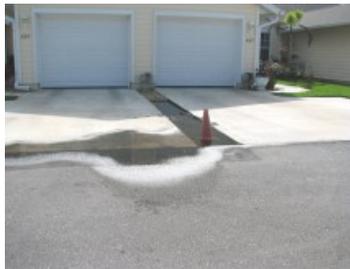
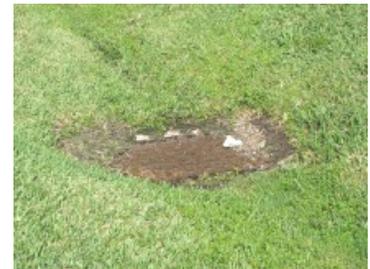
PROPERTY PHOTOS

None; services are performed as needed.
Functional obsolescence is found in effective drainage.
Adjustments are required to decrease standing water and areas with poor pitch.
Drainage systems will require additions of swales, culverts, and a perimeter wall for the retention pond.

Site drainage is accomplished primarily by topography, while assisted with subsurface systems, catch basins, and concrete roadway swales. There are a multitude of issues regarding site drainage, with most related to original construction quality. Issues include improper finish pitch of grades, soil compaction for roads, and proper transitions from road surfaces to concrete swales. The retention pond is observed with bank soil erosion due to a lack of riprap walls or headwalls/bulkheads. Subsurface systems may be disconnected. Management should gradually phase corrections to prevent substantial losses that may eventually impact the residences. Surface water catch basins are observed with some degree of standing silt. Cleaning is required as an operating expense. Future adjustments will require additional swales to overcome trapped and poorly pitched areas, catch basin rebuilding, and possibly correcting and repositioning subsurface piping. Coordinate repairs and enhancements with asphalt adjustments. An annual reserve rate and expense of \$2,000 is included for all years, allowing for constant adjustment and enhancement. Management has an understanding that this scope of work is only a small fraction of the overall attrition and losses that exist.

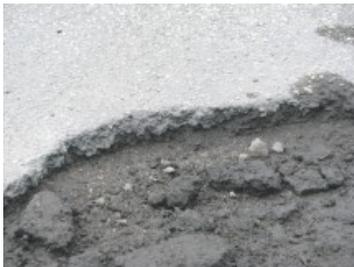
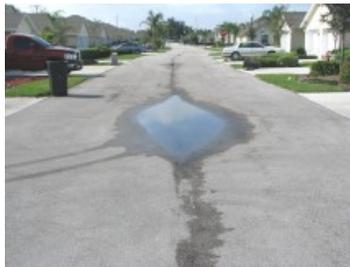
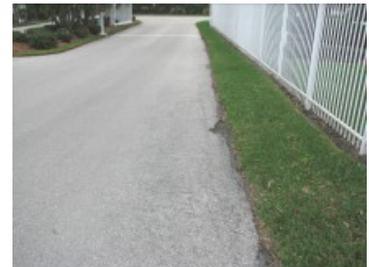
PROPERTY PHOTOS

Intentional deferment is not observed.
There is partial economic obsolescence within asphalt surfaces.
The asphalt inventory requires sectional patching and overlay surfaces to prevent substantial losses.
Concrete surfaces should receive periodic applications of concrete sealer/hardener as an operating expense.

Asphalt surfaces are observed with defects and losses. Issues include poor initial construction quality due to inferior soil compaction, lacking proper termination at edges transitioning to grounds, seam failures, and settlement/movement in numerous areas. The current rate of attrition will present severe losses impacting the value of divided and undivided interests. Immediate expenses are required to prevent accelerated losses, patching open and failing seams, filling breaks and divots, and swaling asphalt to allow for drainage into gutters. These types of adjustments should be conducted as an operating expense. Overlay wearing courses are needed at the front entry area within the next year. Wear patterns are creating surface spalling and movement. Wear course enhancement should occur for all surfaces within the next 10 years. The function might be delayed if operating repairs are proficient.

Concrete surfaces vary in conditions from fair to good. Concrete surfaces include swaled roadway gutters, driveways, and walkways throughout the site and to each residence entry. Original installation quality was reasonable and typical of modern construction. Conditions include cracking related to settlement and climate, minor surface spalling, and minor movement. Operating maintenance requires improvements to address conditions, including crack filling with epoxy injection, minor patching, cleaning mold and mildew, and sealing with a concrete surface sealer/hardener. Replacement is unlikely if maintained properly; however, deferred maintenance may become a capital expense. The inventory is substantial with 38,352 square feet of surface area covering driveways, and 47,310 square feet of surface area covering gutters and walkways. An annual reserve rate of \$1,000 per year is included to address deferred maintenance of the future.

The inventory includes 52,800 square feet of surface area improved at \$1.75 per square foot. Total overlay costs are estimated at \$92,400 reserved over 10 years at \$9,240 each year. Expenses of \$30,800 are included below for years 8, 9, & 10. Management should consider accelerating the expenses to correct original conditions. The reserve rate reverts to typical use life of 25 years, at \$3,696 each year. As an oil-based product, expect inflation to have an impact on costs. Alternative functions are also available, including slurry mix coating, sealcoating, crack filling, and shimming. Not all functions qualify as an allowable reserve account expense.

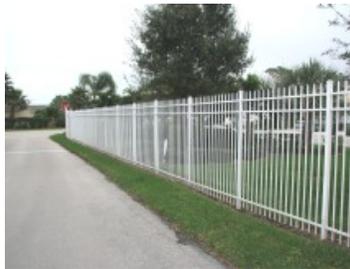
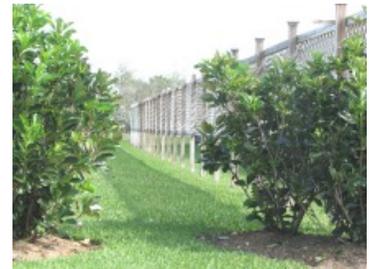
PROPERTY PHOTOS

Site lighting includes an inventory of 21 fiberglass posts and lanterns with high pressure sodium fixtures. Long term use is possible with regular service as an operating expense. Include inspection and surface sealing foundations, assuring open drain holes within the fixture head during lamp changes. The inventory value is \$35,175 reserved over 40 years at \$879 each year. Capital expenses are not included.

The fence inventory includes original and recent improvements with vinyl covered chain link, decorative security gates, decorative metal fence at the entry and pool area, and wood lattice screen. Inventory value is estimated at \$36 per linear foot, at approximately \$40,536 reserved over an average of 30 years of use. The annual reserve rate is \$1,351 per year for all years. Metal surfaces will eventually require film coat protection, as will recent wood products. See page 9 for a discussion regarding film coat costs. The current inventory should be capable of achieving an additional 20 years or more of service with reasonable maintenance. No capital costs are included at this time.

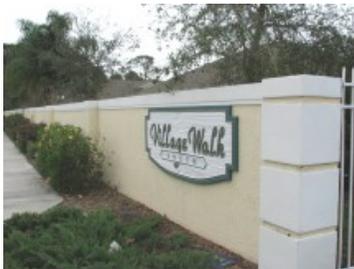
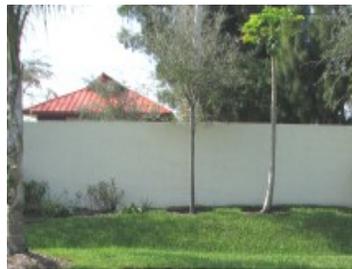
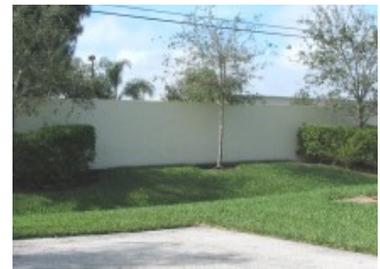
PROPERTY PHOTOS

The site is improved with a CMU wall finished with a stucco and film coat surface. The wall is attractive and in good condition. There are sporadic locations of weather and water penetration with indications of strikes from grounds equipment. Conditions are minor, with long term use of 30 or more years very likely. The structural wall receives a token level funding rate of \$100 to recognize the inventory. Adjustments may be required to the funding level in the future should operating maintenance be insufficient.

The site is improved with an inventory of decorative theme identification signs and instruction/direction signs within the development. The inventory value is less than \$10,000 leaving costs to the operating accounts. Management is aware of the importance of curb appeal related to attractive signs.

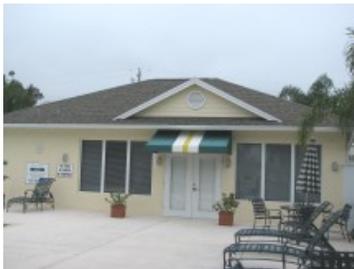
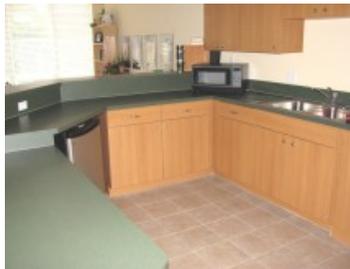
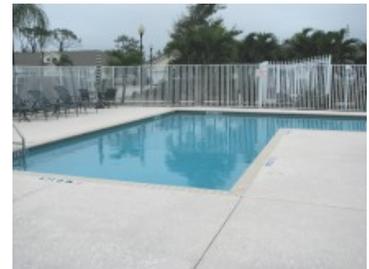
PROPERTY PHOTOS

The community building includes a single level 1,165 square foot footprint finished with restrooms for the swimming pool, an attractive utility kitchen, and an open function area with finished flooring. The association has provided an attractive facility with minimal costs. Future plans include additional furnishings and finishes. A chart of components and anticipated expenses follows:

The swimming pool includes two forms of reserve to address short and long term items. Pumping, filtering, and water treatment are relatively short use life items requiring cyclic expenses. Years 3, 10, & 17 include an expense of \$2,500 for replacement components. The reserve rate is \$357 per year for all years. Actual timing of expenses will likely vary with failure and replacement being crisis driven. The structural pool is refinished over the long term of 20-25 years, requiring an expense of at least \$25,000. The annual reserve rate is \$1,000 per year for all years. The total reserve rate for the category is \$1,357 per year.

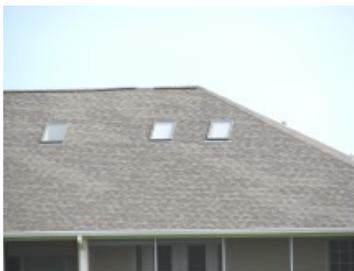
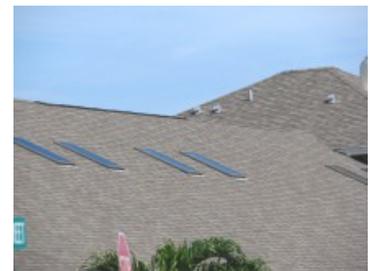
PROPERTY PHOTOS

The roofing inventory is the most substantial component and expense observed at the site. The inventory includes an architectural shingle of at least 345 lbs./sq. with an original use life of 20-25 years. While the manufacturer may state an expected use life of 25 years, 20 years should be average and most likely to be achieved. The average residential unit is improved with 1,900 square feet of product including pitch and waste. Total inventory is estimated at 193,800 square feet of surface area improved at \$6.50 per square foot. Total value is \$1,259,700 requiring an annual reserve rate of \$62,985 based on an average of 20 years use life. Original construction was phased over a three year term during years 2000-2002. Accordingly, roof replacement is shown during three phases in years 18, 19, & 20 at \$419,900 each phase.

Critical analysis considers conditions to be generally excellent. Observations include sporadic fastener failures, indicated by the "fish-mouth" appearance and some movement around skylights. Granule surfaces are excellent and like new; valley weaves include several locations of movement. Product finishes may be "end-lot" being observed with differing patterns as seen in the photo below to the left. An EPDM membrane (Grace Ice & Water Shield) should have been installed in this type of application, especially at the ridge and valley locations.

None; services have been proficient.
Association documents do not address lines of ownership and delineation, and should be considered functionally obsolete.
Consider an annual service plan with a qualified roofing contractor after the manufacturer's warranty expires.
Alter the association documents clearly describing lines of ownership.

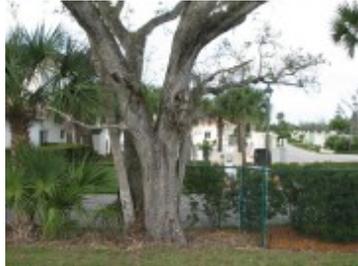
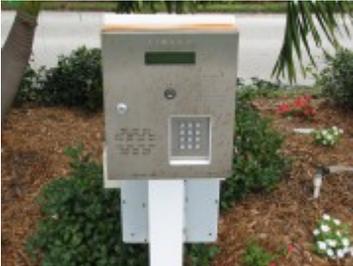
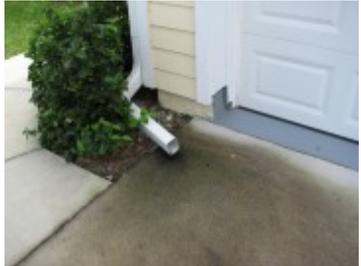
PROPERTY PHOTOS

Intentional deferment is not observed in any component of the property.
 Functional obsolescence could describe wood products in this environment.
 Constant inspection followed by film coat protection is needed to prevent losses.
 Most components are modern and appropriate for the use intended.

The swimming pool may be improved with a lift chair.
 Entry gates are being abandoned, defeating the purpose of a gated community.
 The intercom system is not utilized as part of the security process.
 Lighting may be insufficient in some areas, requiring additional enhancements.
 There are no security cameras or other devices of a security nature.
 Sump pumps and protective pumps may be required to address some of the drainage and surface water issues.
 The retention pond may require silt removal in later years.
 Wood products are applied as envelope siding, presenting a relatively short use life product requiring cyclic film coat expenses.
 Film coat products should be a latex solid body stain with an acrylic base including a manufacturer's warranty of at least 7 years.
 There are several locations of the building envelope where management will need to assume control, although not necessarily ownership acting as the unit owner's agent, to protect architectural and physical integrity. These efforts would normally be compensated to the agent as construction supervision fees.
